Job History

Highway 897

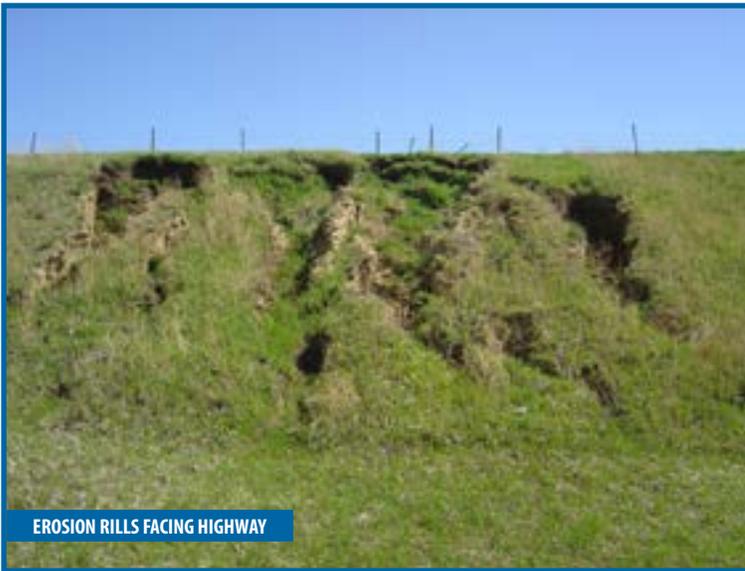
EROSION RILLS FACING HIGHWAY

At this site, erosion of the ditch bank facing the road caused unsightly erosion rills. Left untreated, these would pose problems with further erosion and possible loss of land for the neighboring field.

Soil Lynx, and its ability to bind soil in place and tackify natural soft armoring to the slope were to be put to the test.

For the purposes of the project, no outside seed was to be used, Clearflow would test Soil Lynx tackification properties with soil and Geo Jute while vegetation growth occurred “naturally”.

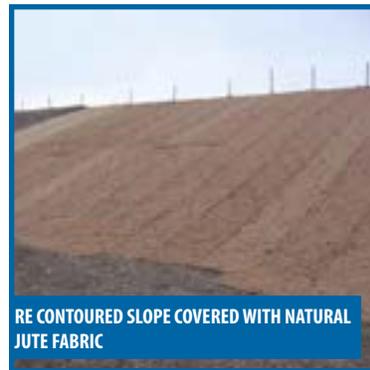
RE CONTOURED SLOPE COVERED WITH NATURAL JUTE FABRIC

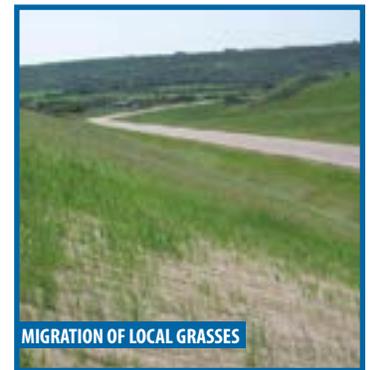
Returning to the site in June of the following year revealed the establishment of local grasses within the reclaimed area. With the Geo Jute acting like micro sties and the Geo Jute / Soil Lynx combination acting together to hold slope in place, substantial natural growth was observed and the water retention characteristics of the Geo Jute and Soil Lynx would further enhance continued growth. There was also no evidence of rills or erosion.

MIGRATION OF LOCAL GRASSES

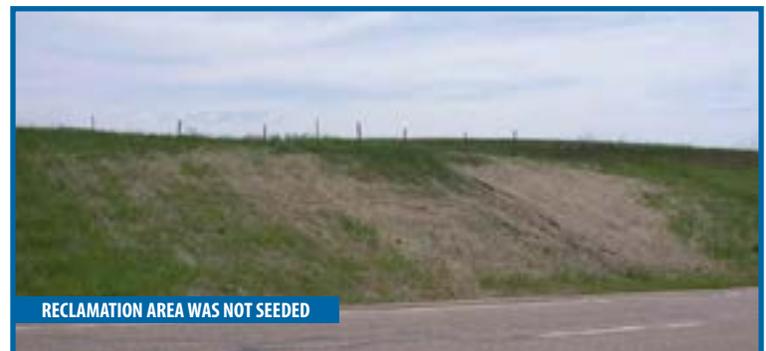
RECLAMATION AREA WAS NOT SEEDED
